# DES MOINES MARINA

## Marina Service Life Report

December 8, 2020

PREPARED BY  
**Reid Middleton**

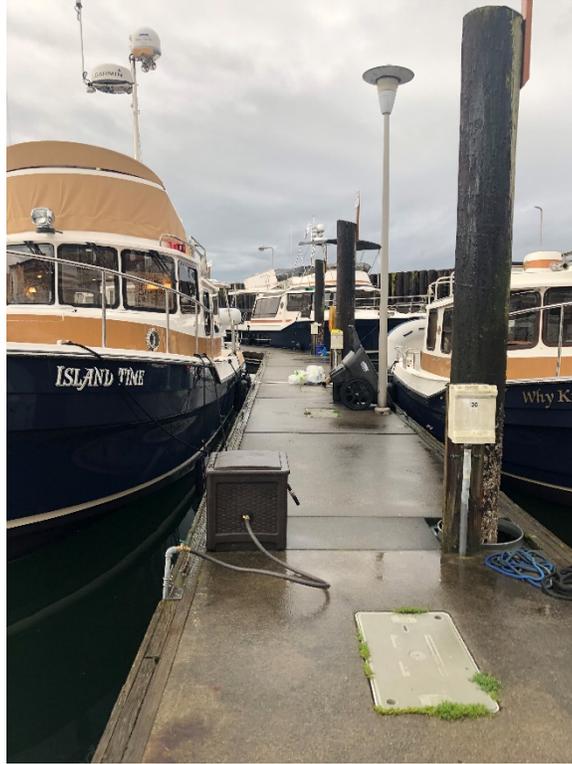
Photo 1. Commercial Dock

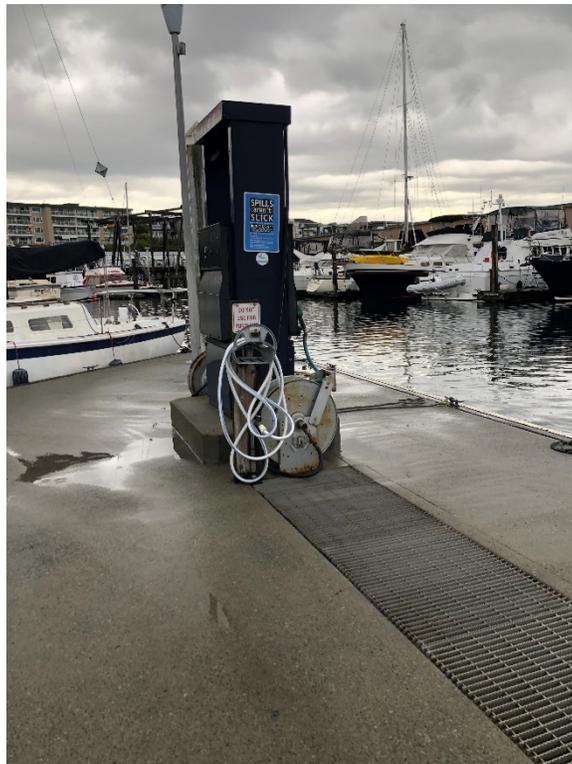
Photo 2. Fuel Dock

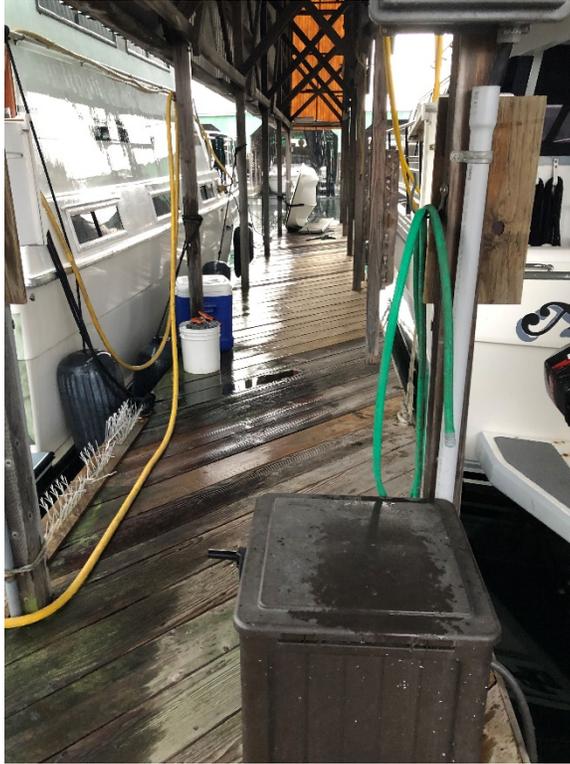
Photo 3. N Dock Timber Finger

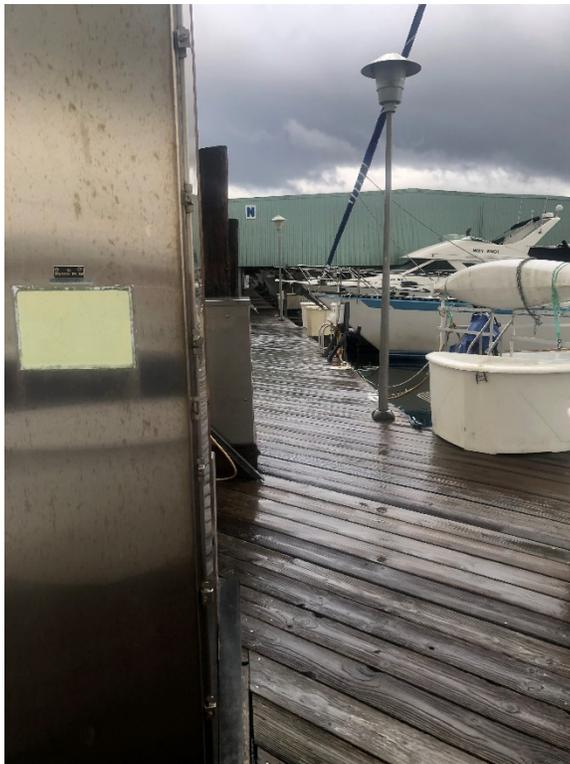
Photo 4. N Dock Open Timber Float

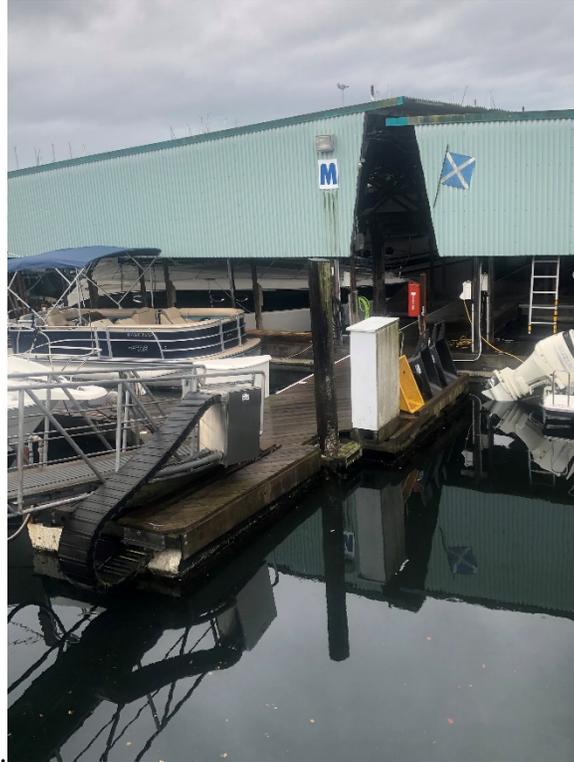
Photo 5. M Dock Roof Structure

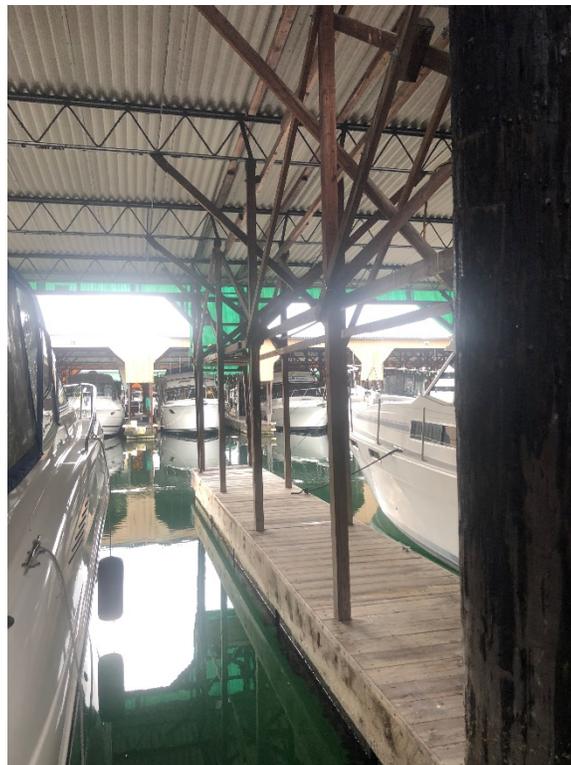
Photo 6. Timber Framing and Roof Structure

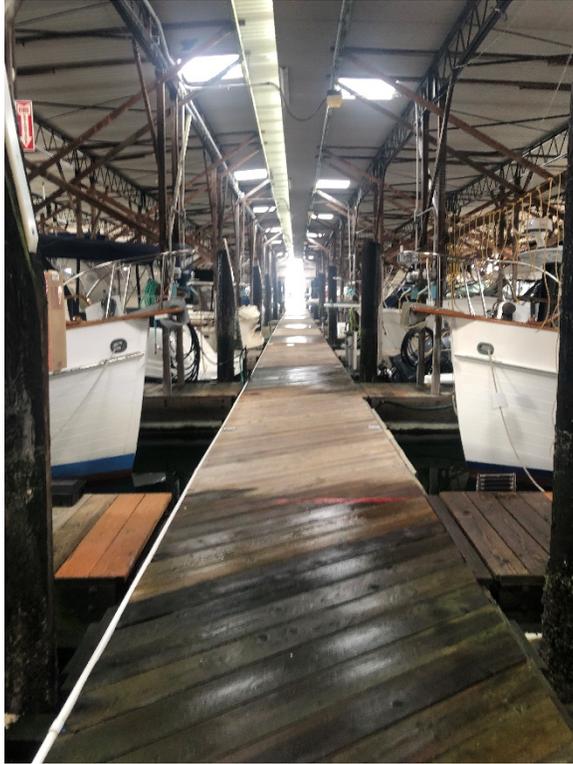
Photo 7. Covered Moorage System

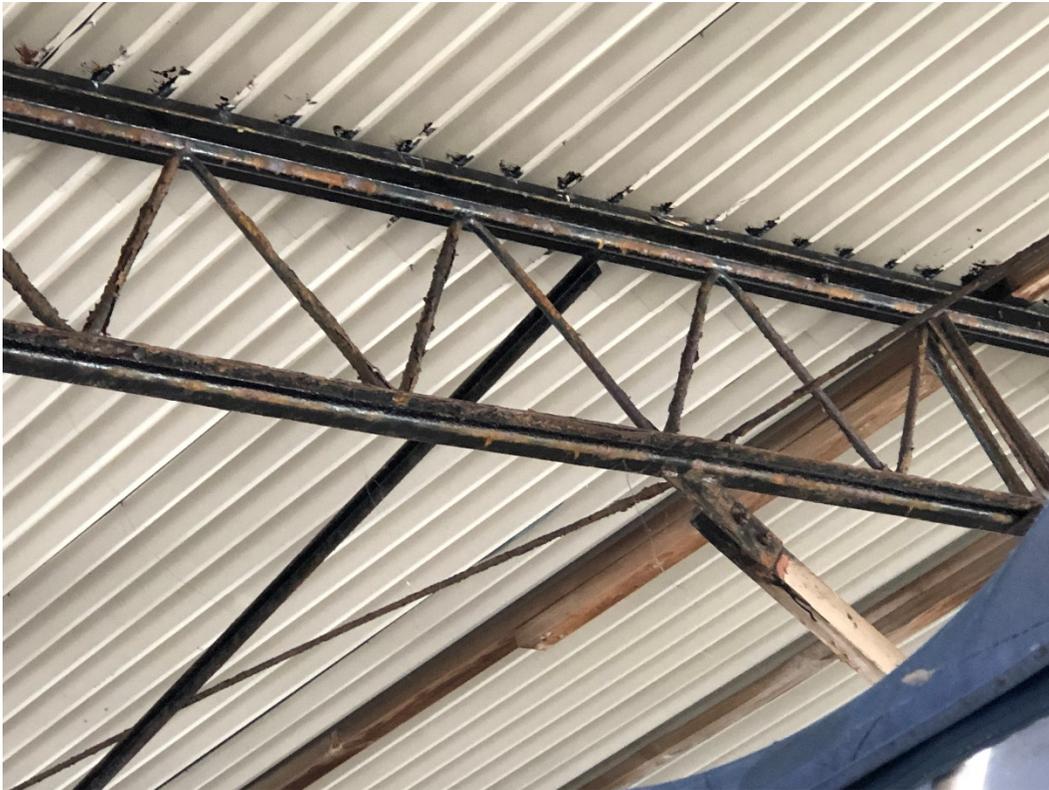
The covered moorage roof system is in poor to fair condition. There are areas where the timber support posts are damaged, and many are showing their age. There are also areas, particularly on the more exposed south sides of the moorage facilities, where there is corrosion of the steel truss members. While the City has a routine maintenance program to scrape and paint the steel truss members, the ongoing corrosion has reduced the thickness of the steel members and resulted in deteriorated conditions and aging of the steel trusses. The roof material is in generally fair condition, with some local areas of deterioration but overall no significant visual evidence of widespread deterioration. The covered moorage roof systems rate in overall poor condition primarily due to the age of the timber supports and corrosion of significant areas of the steel trusses.

Photo 8. Roof Truss Corrosion

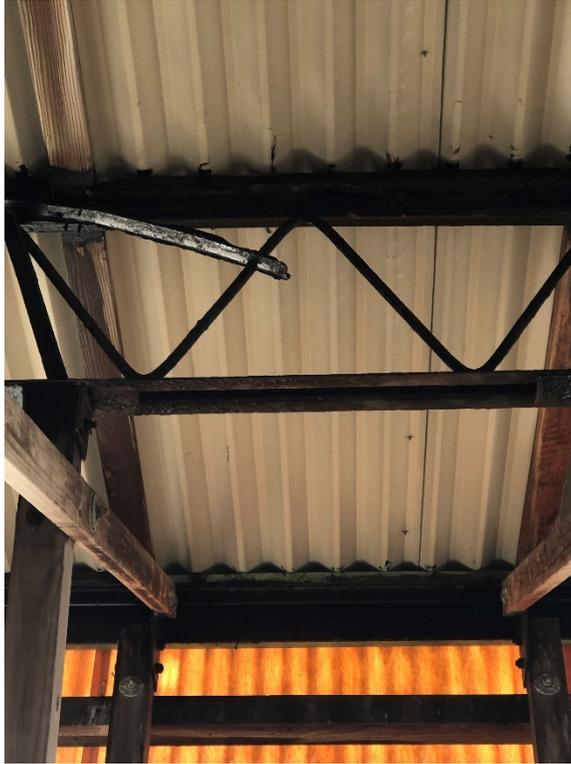
Photo 9. Roof Truss Damage

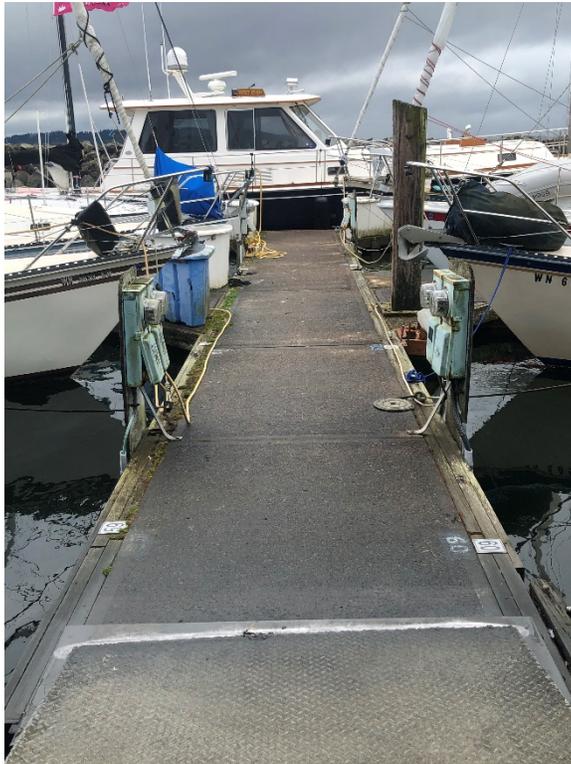
Photo 10. Outer Uncovered Concrete Dock System

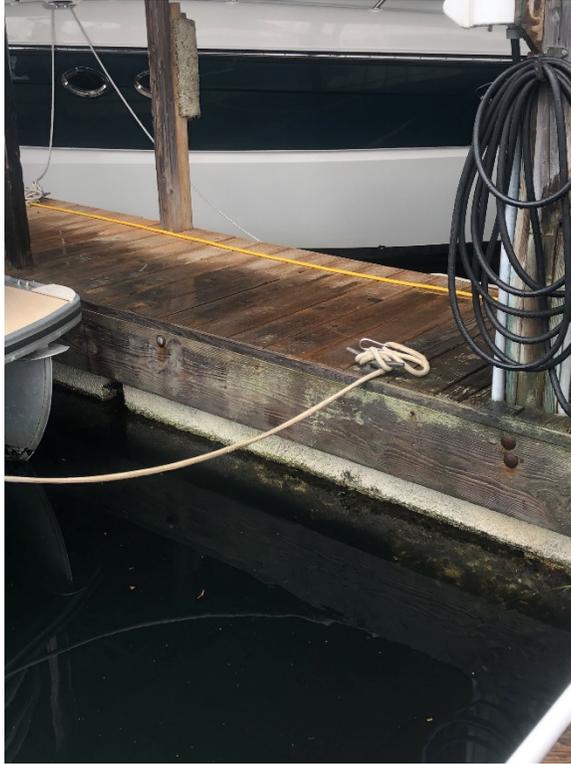
While most of the unencased flotation appears to be still intact, evidence of saturation and areas of loss of adhesion and separation of the flotation materials can be seen throughout the dock systems. Some of the deterioration is likely caused by mechanical means (impact from vessels, prop wash, and otter nesting) but it also appears that the flotation is deteriorating based on its age and loss of cohesion. Given the age of the flotation units, it is expected that this breakdown will accelerate. The unencased flotation is rated in poor condition. The encased flotation is generally newer and is rated in fair to good condition.

Photo 11. Timber Float with Unencased Flotation

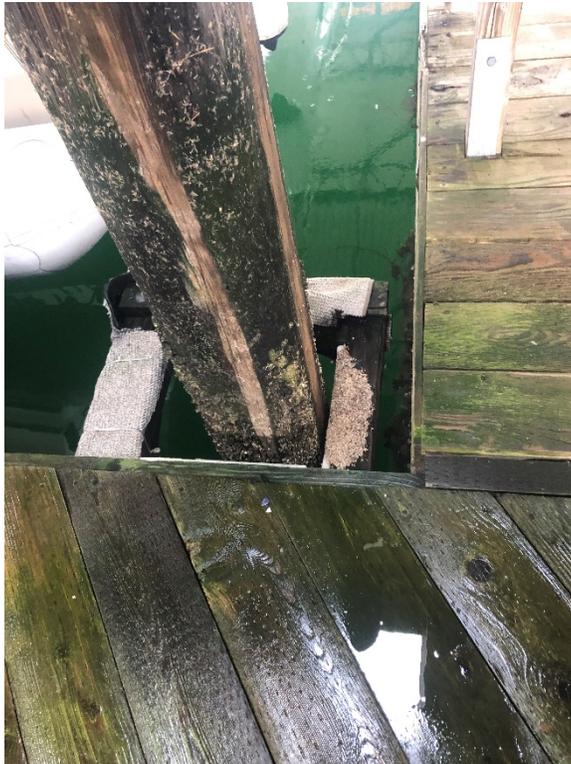
Overall, the timber piling within the marina are in good condition given their age of approximately fifty years. The piling observed showed some abrasion damage but no widespread deterioration or marine borer damage. A small percentage of the piling (approximately 3 percent per maintenance staff) have deteriorated and have either been cut down to the mudline or removed and replaced with steel piling. The City expects to replace or remove a small number of additional piling, which will be identified through routine inspection and maintenance processes. Overall, the existing piling are anticipated to have a longer remaining service life than the existing timber float and covered roof system and are therefore not the critical element in estimating the remaining life of the overall moorage systems.

Photo 12. Timber Pile with Abrasion

The piling were noted to have mainly abrasion damage and are anticipated to outlive the existing float system. However, the existing treated timber piling should be replaced as part of the overall dock replacement work for configuration, life cycle, and environmental purposes. New utility systems and appurtenances should also be installed as new dock laterals are constructed to meet current code and operation requirements.

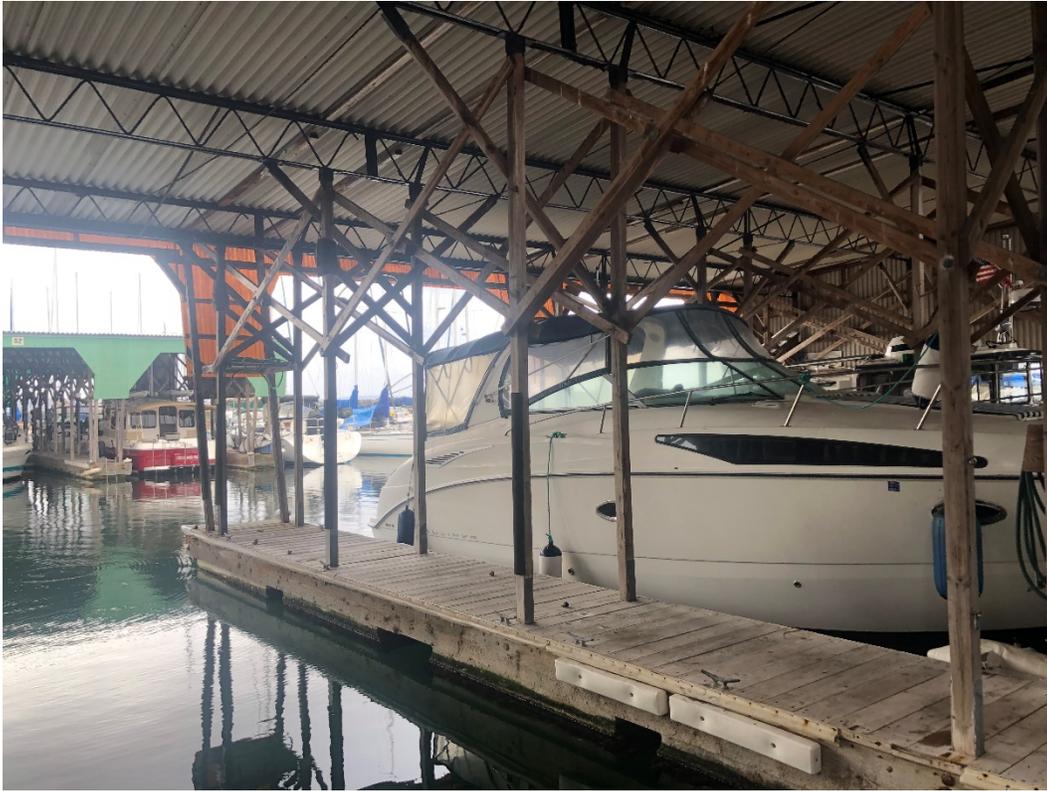
Photo 13. Covered Moorage System Timber Float

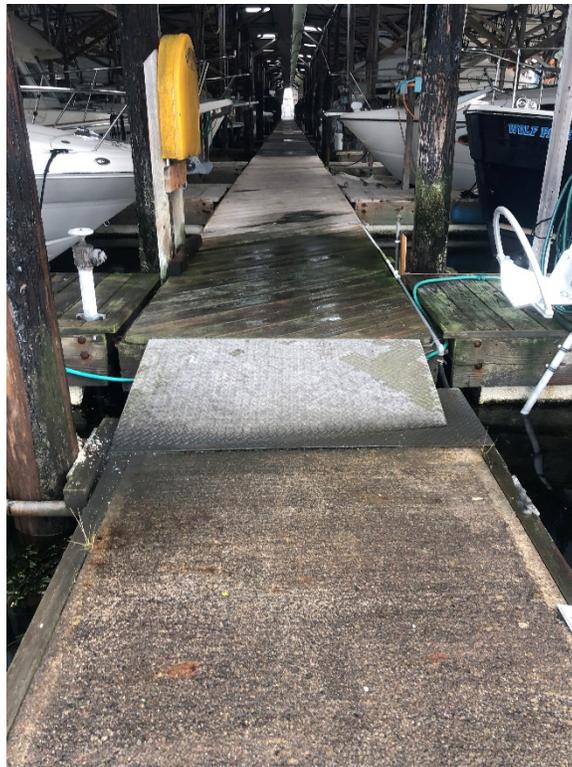
Photo 14. Transition from Timber to Concrete Dock

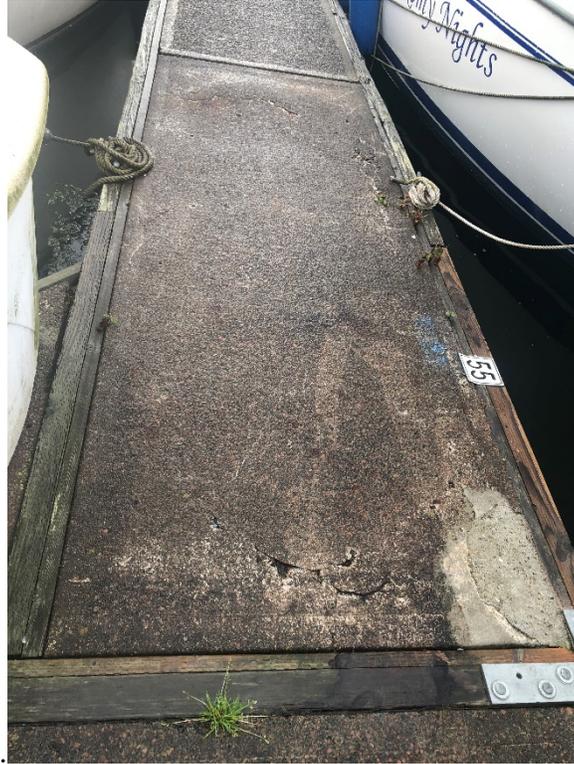
The concrete float systems within the marina are in fair to good condition. The decks of the concrete pontoons are in overall good condition. However, the concrete floats are starting to show some locations and evidence of delamination, spalling, and corroded and exposed

reinforcement. The City marina staff has implemented regular routine maintenance and capital projects to replace the structural component of the concrete float systems (waler and thru-rods) throughout the marina, which has and will continue to extend the life of the concrete dock system.

Photo 15. Outer Concrete Float Showing Deterioration

Repairs to replace substantial float components, particularly for the concrete float modules, walers, thru-rods, utilities, pile hoops, decking, etc., can extend the life of the concrete float systems. While repairs to some selected locations of the concrete floats (such as the extensions on F, G, H, I, J, and L Docks) may be beneficial, repairs of the entire concrete float systems and timber float systems are not recommended and would not be cost efficient. Repairs and component replacement will not be cost effective for the existing timber floats and roof structures given their age, overall conditions, and potential for increased rates of deterioration. Therefore, complete replacement of the timber floats and roof systems is likely to be more cost effective over substantial repairs to these structures.

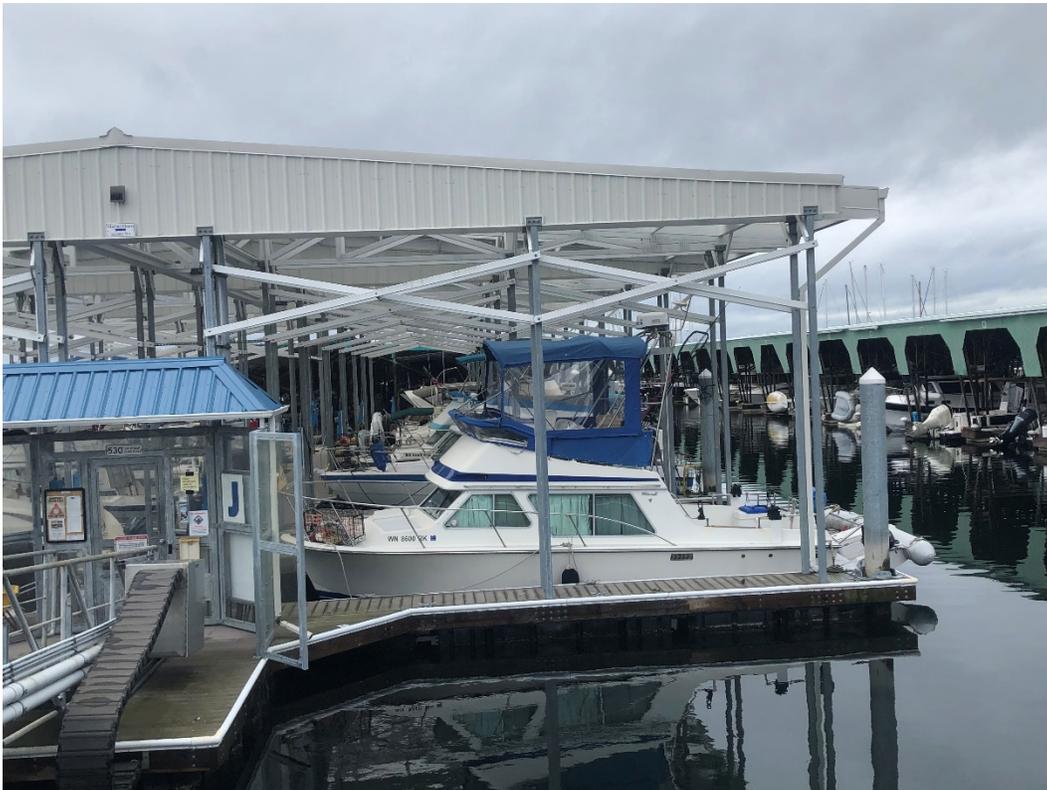
Photo 16. New J Dock Covered Moorage System

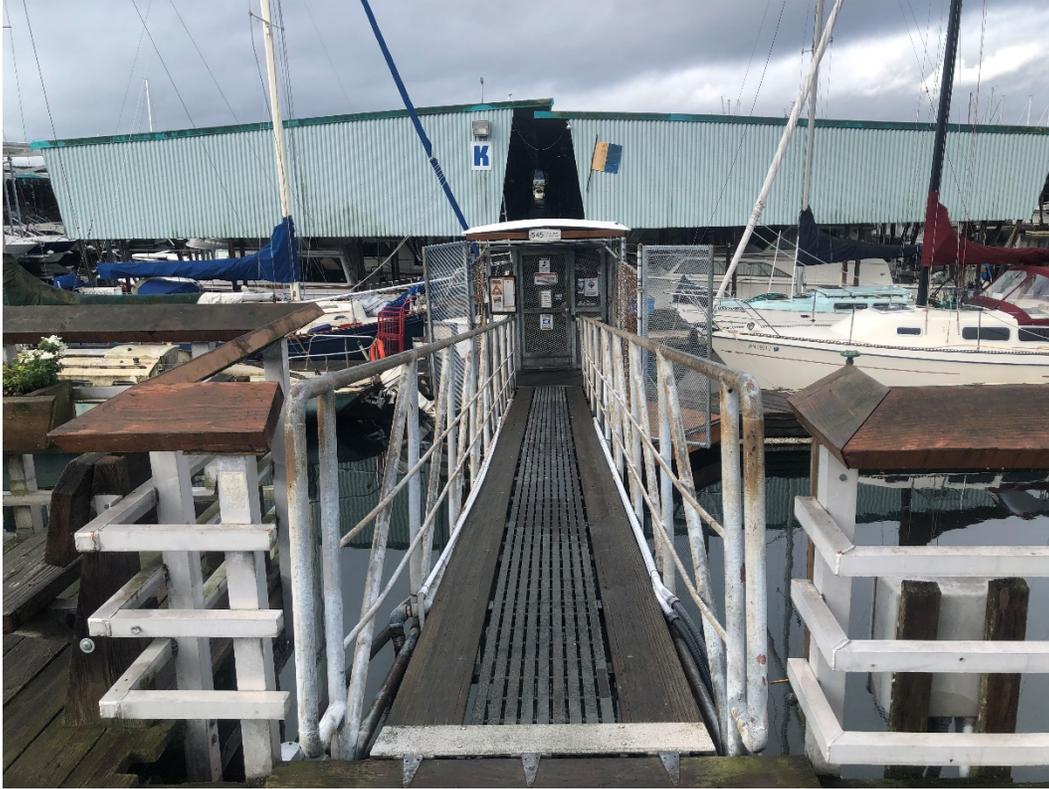
Photo 17. Gangway and Covered Moorage

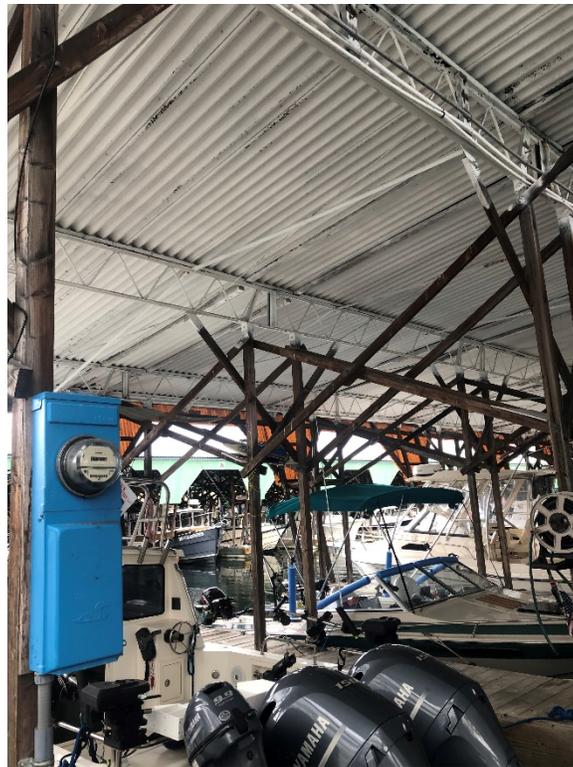
Photo 18. Electrical Service and Painted Truss

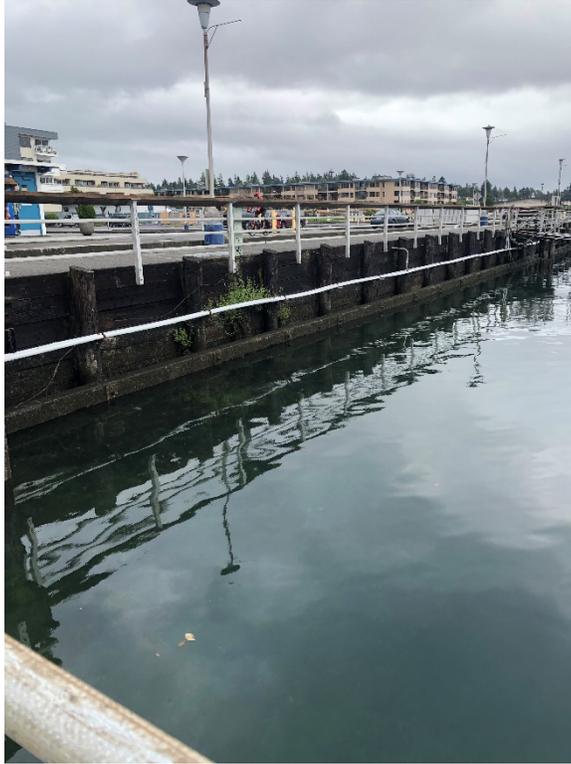
While a detailed visual assessment of the existing seawall was not conducted, the overall condition of the seawall was observed. Given the deterioration of the timber seawall, it is likely that significant seawall repairs or major renovation and replacement of sections of the seawall will need to be made within the next five to ten years. It is recommended that a detailed inspection of the seawall be conducted if one has not been done recently and consideration for seawall repairs and replacement be included in the overall planning for stewardship of the marina.

Photo 19. Seawall

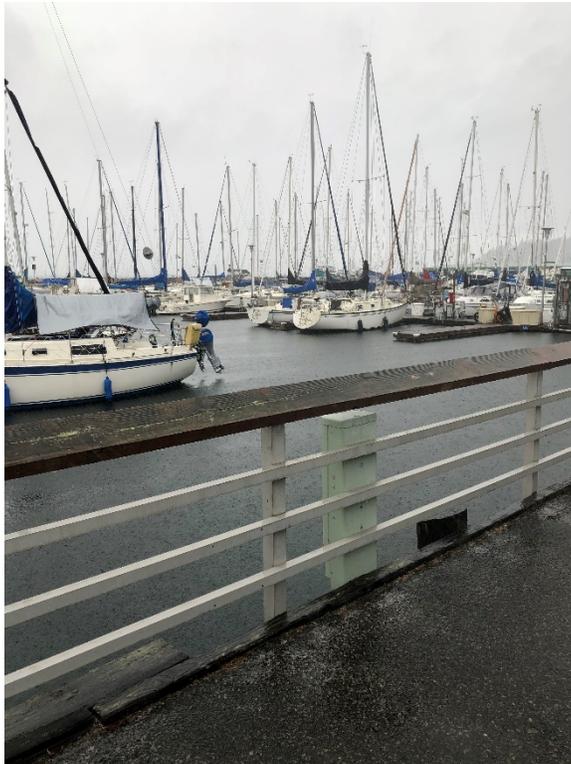
Photo 20. A and B Concrete Docks
