Des Moines Marina Boat Launch Technical Memorandum

May 18, 2022

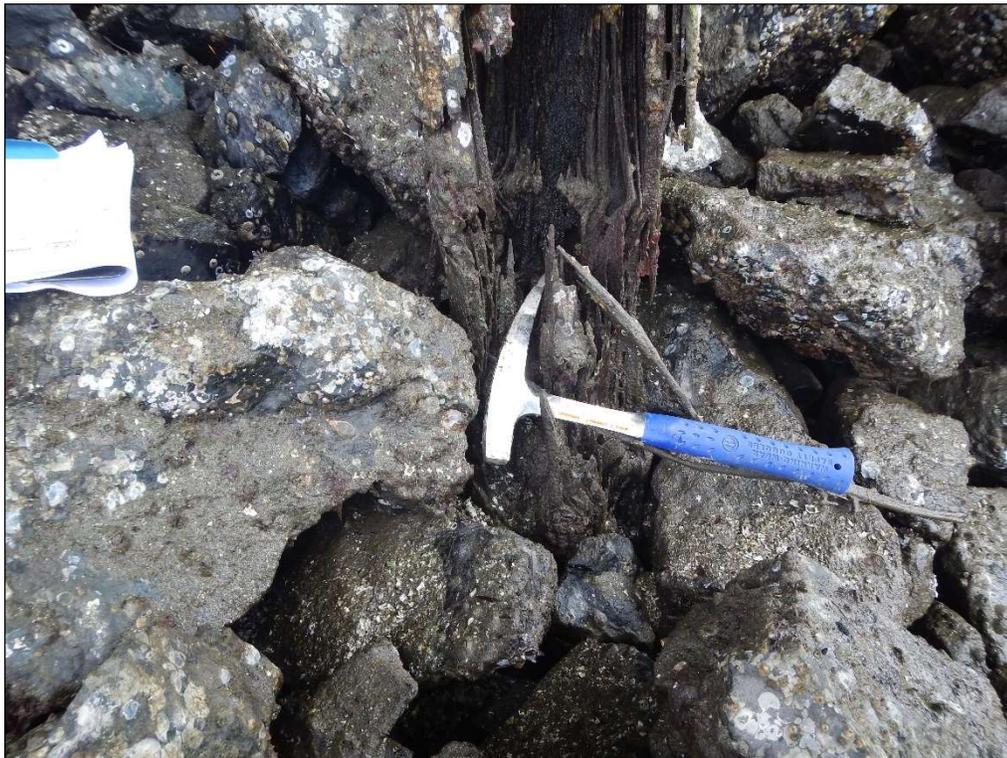
8. Rot through entire pile, 4' high starting at ground line, Bent B Pile C.
