City of Des Moines Marina Service Life Report
Des Moines, Washington
December 8, 2020

As part of the overall process, the City of Des Moines requested that Reid Middleton perform an evaluation to determine the estimated remaining design life of the inwater portions of the marina moorage dock facilities. The intent of the evaluation is to estimate when the inwater moorage facilities will require replacement to enable the City to plan effectively for replacement of the aging inwater facilities. The estimated design life remaining along with the planning work being conducted by others will assist the City in determining appropriate phasing and replacement timing for major capital rehabilitation projects for the marina facility. This report provides a summary of the estimated remaining life for the inwater moorage dock facilities at the marina.

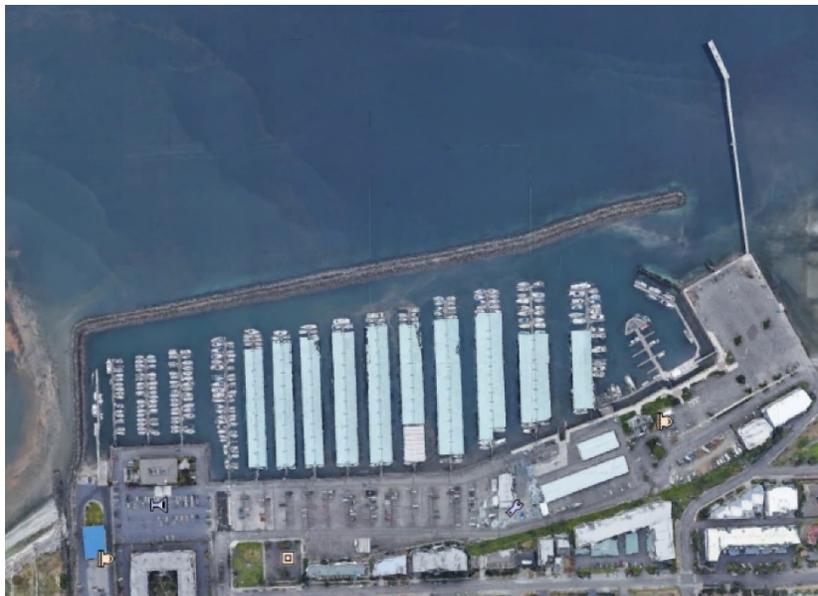
Figure 1. Des Moines Marina.

The Des Moines Marina is in Des Moines, Washington. The Des Moines Marina provides moorage for approximately 840 vessels, with slips ranging in size from under 30 feet to larger end and side ties for boats up to 62 feet. The marina is owned and operated by the City of Des Moines. The main marina was constructed in the late 1960s and completed in 1970, with outer uncovered dock extensions on E to M Dock laterals added in around 1975. The marina consists of an offshore rubblemound breakwater and an interior moorage basin with a single marina entrance located on the north side of the facility, see Figure 1. A public fishing pier and timber breakwater are located near the marina entrance. The interior basin was built by construction of a timber seawall along the entire shoreline and dredging of the marina basin.

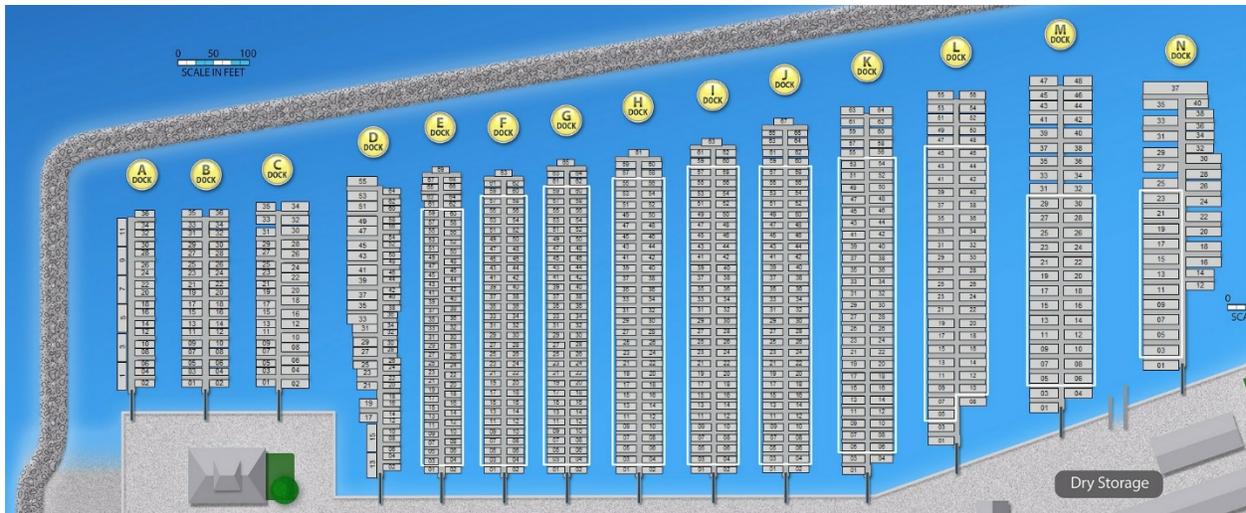
Figure 2. Dock Layout for Des Moines Marina.
 (Source desmoinesmarina.com)

The Des Moines Marina docks include fourteen main dock laterals starting with A Dock in the south and extending north to N Dock, see Figure 2. The boat ramp is located south of A Dock. The fuel dock and commercial dock are located north of N Dock. The inwater portions of the marina consist of a combination of uncovered and covered moorage floating docks anchored primarily with the original timber piling. The entire A Dock through D Dock and small portions of the outer sections on E Dock through N Dock are uncovered moorage. Most of the areas on E Dock through N Dock consist of covered moorage facilities.

The floating docks at the marina consist of a combination of timber floats with unencased flotation and modular concrete pontoon floats. The timber floats are in the covered moorage areas and on the uncovered sections of M and N Docks. The concrete docks at the marina consist of small (10- to 12-foot-long) modular concrete pontoons connected by a structural system of wood walers and thru-rods. The floating docks are anchored with timber piling, though replacement with steel piling has been done in limited areas. The covered moorage system consists of timber posts, steel truss framing, and corrugated roofing. Most of the floating dock, covered moorage structures, and piling are original construction.
