**City of Des Moines Marina Service Life Report**  
**Des Moines, Washington**  
**December 8, 2020**

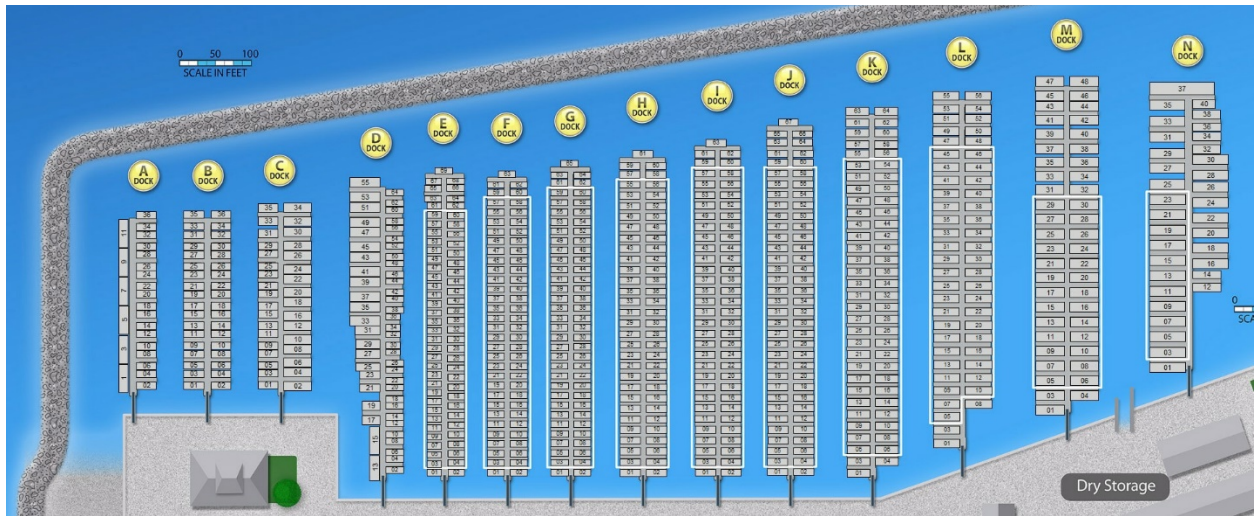
Figure 2. Dock Layout for Des Moines Marina.  
 (Source desmoinesmarina.com)

The Des Moines Marina docks include fourteen main dock laterals starting with A Dock in the south and extending north to N Dock, see Figure 2. The boat ramp is located south of A Dock. The fuel dock and commercial dock are located north of N Dock. The inwater portions of the marina consist of a combination of uncovered and covered moorage floating docks anchored primarily with the original timber piling. The entire A Dock through D Dock and small portions of the outer sections on E Dock through N Dock are uncovered moorage. Most of the areas on E Dock through N Dock consist of covered moorage facilities.
